Project Profile

Project Location: Rte. 10 onto I-287 Mt. Hope, NJ
Date Placed: October 1997
Traffic: 3million ESALs

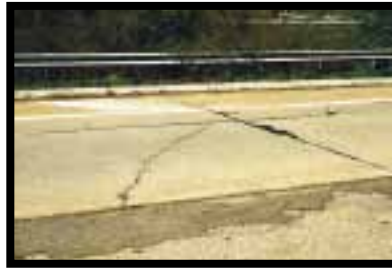
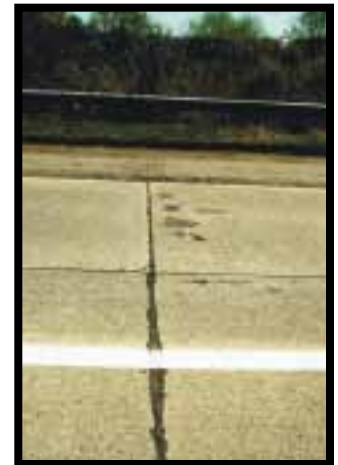
**Surface condition
prior to overlay with
Strata® interlayer.**

Previous Condition: 9" PCC—Stable, poor joint condition
Joint Spacing: 76'
Reinforcement: Doweled
Surface Preparation: PCC patched full depth

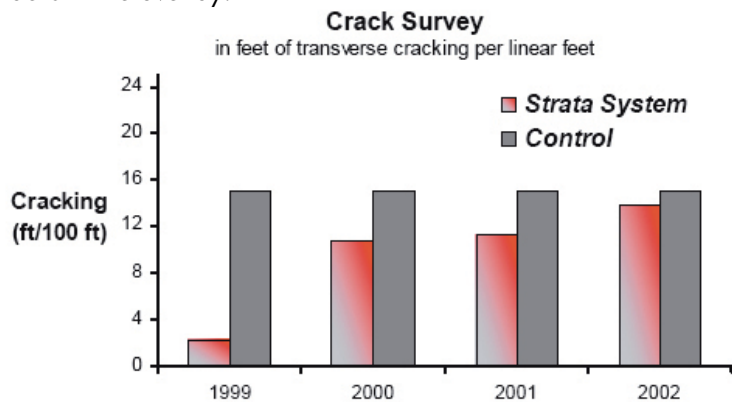
The state is pleased with the performance and is implementing a standard specification for the interlayer. The graph shows cracking survey results. Cores were taken directly over cracks in the overlay:

Strata® Section: 6 Cores, 0 cracks directly over PCC joint, interlayer not cracked
Control Section: 4 Cores, 4 cracks directly over PCC joint
