Project Profile

Project Location: 24th St, Ogden, Utah
Date Placed: 2002
Traffic: 6,900,000 20-year ESALs

Strata® and Control Cross-Sections

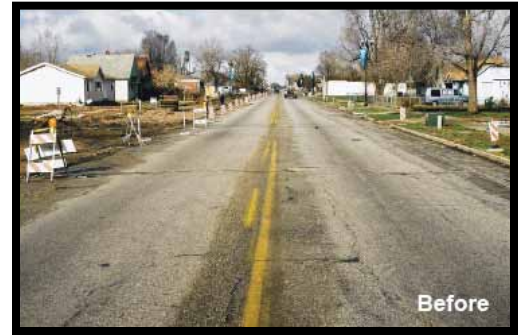
Before

Existing Surface Condition

Pavement: Composite: 5.5" of PCC, 6" of asphalt
Condition: Poor to fair, medium to high severity transverse cracks.
Surface Preparation: Widening, new curb & cutter, surface milled to achieve 2 percent crossslope and level-up course applied to provide a uniform surface.

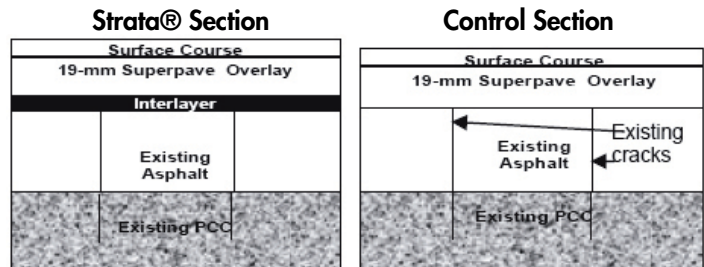
Interlayer thickness: 1" on Strata® Section
Overlay: 1.2" plant mix seal coat (open-graded friction course)
 3" 19-mm Superpave Mix
Overlay PG used: PG 64-34

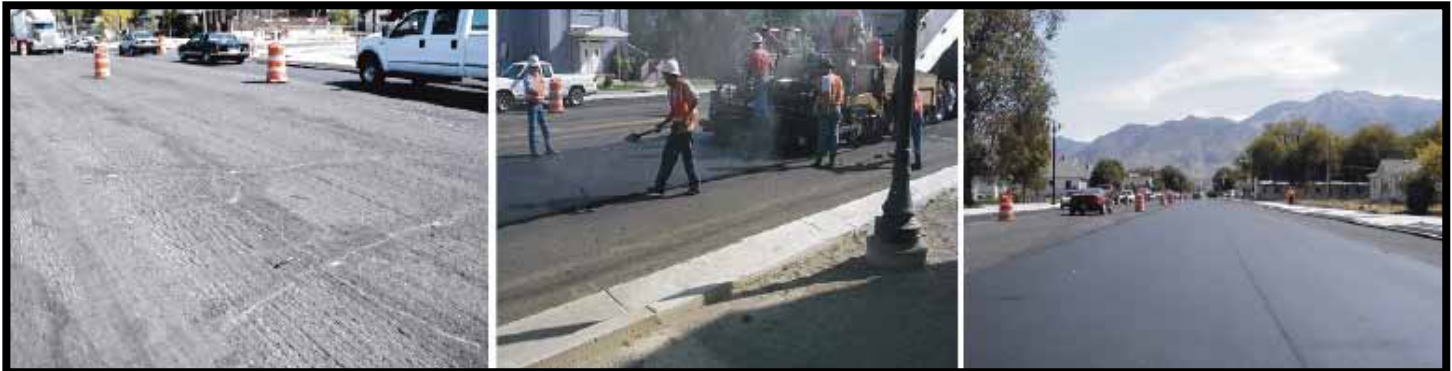
Prepared Surface before Construction

The Interlayer Before Overlays

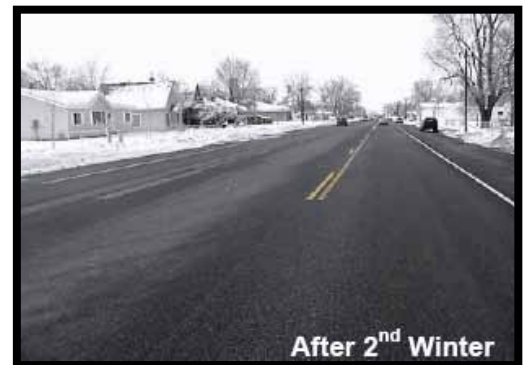
After 2nd Winter

The Utah Technology Transfer (T2 center) was asked to document the construction process and provide annual field evaluations over a period of seven years. The ambitious test plan includes a base map of the new roadway alignment using Global Positioning System technology, a map of the existing cracks, digital photographs and exhaustive data of every crack and pothole surveyed, core samples after the interlayer (and before overlay), field notes and photographs taken during construction. The yearly assessments will include a condition survey with surface evaluation and a traffic evaluation. These will document the performance of both the interlayer and the HMA overlays. The construction, quality control tests and core evaluation met all criteria. The one- and two-year evaluations showed no significant cracking in any sections. The photo shows the project after the 2nd winter. The Utah T2 center has a project report on its website at <http://www.utaht2.usu.edu>.
