# Project Profile

**Project Location:** US 36, Cameron, MO  
**Contact:** Jason Bloomberg, MoDOT, 573/526-4338  
**Date Placed:** June 2000  
**Traffic:** 7 million ESALs (8100 ADT, 12% Trucks)

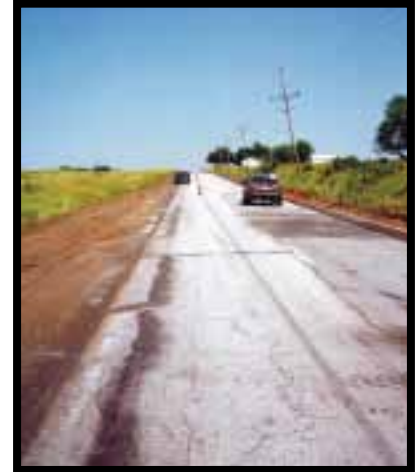
Surface before treatment

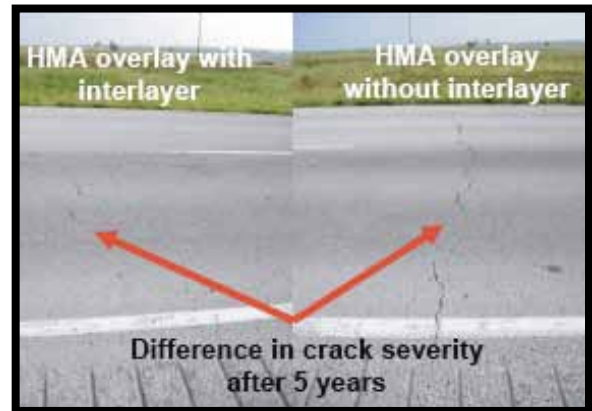
The project has been monitored yearly. The photos and graph show that the Strata® reflective crack relief system has been outperforming the control for 5 years. Three cores were taken from cracks in the interlayer section; in all cases the interlayer was intact, and the surface cracks were offset from the cracks in the underlying PCC.

Performance after 5 years
